Petrographic Analysis of Cores from Plant 42

E. Rae Reed-Gore, Kyle Klaus, and Robert D. Moser

October 2016

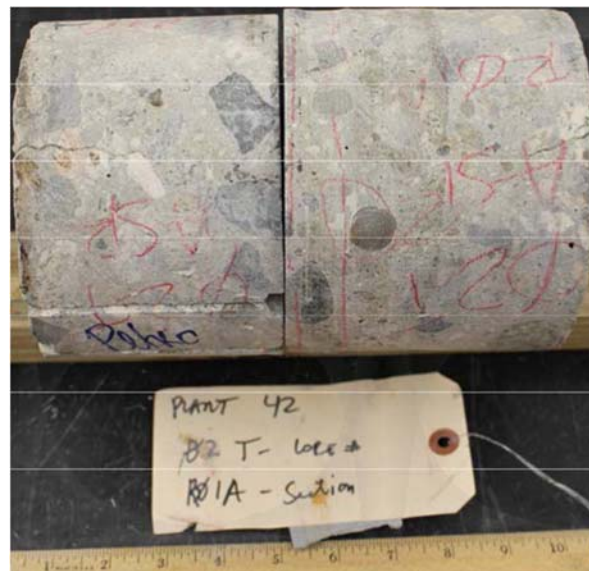
Figure 2. The as-received core 160143-1 (O2T).

The as-received core 160143-1 (O2T) is shown in Figure 2. The core was 8.5 inches long and 6 inches in diameter. There were 2 cracks greater than 0.5mm in width, one extends 3 in into core, extends through 2 coarse aggregates and terminates at a coarse aggregate. The second crack extends 3.5 in into core, extends around 1 coarse aggregate, but through 4 others. Carbonation staining is within the top inch from the surface. There was some staining along the longer crack, indicating the crack was most likely a shrinkage crack from construction. There was minor aggregate distress observed, but no severe ASR deterioration observed. See Figure 3 for low and high magnification microscopy images of 160143-1 (O2T).

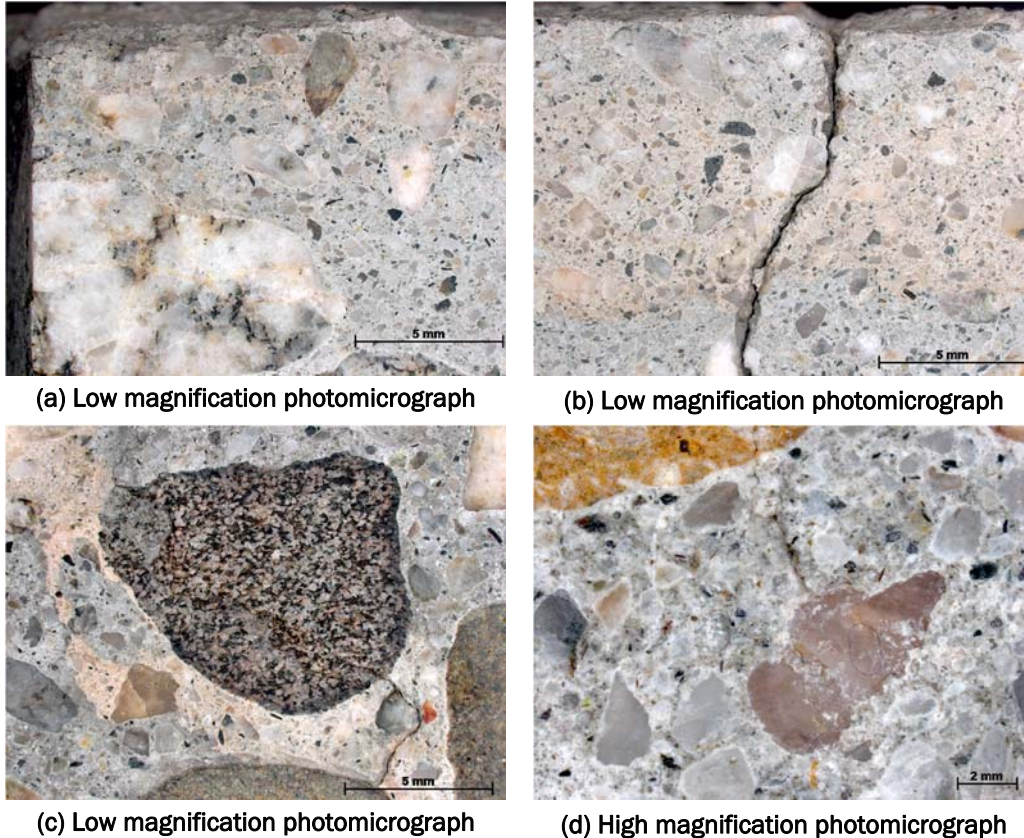
Figure 3. Low and High magnifications of 160143-1 (O2T). (a) minor carbonation staining at the surface, (b) carbonation staining and crack at the surface, (c) carbonation staining around cracked aggregate, (d) high magnification to see fine aggregate and cement, minor cracking.

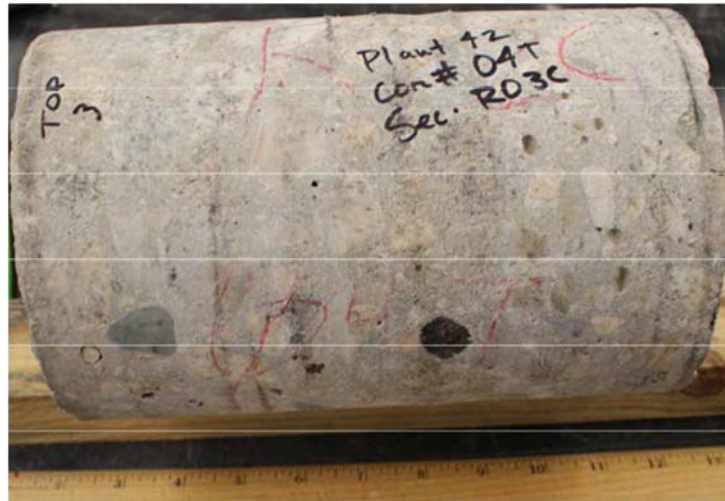
Figure 4. The as-received core 160143-2 (04T).

The as-received core 160143-2 (O4T) is shown in Figure 4. The core was 8.75 inches long and 6 inches in diameter. A crack over 2 in into concrete, greater than 0.5mm width, extends through 2 coarse aggregates and terminates at a coarse aggregate. Carbonation staining is within the top inch from the surface, mainly around aggregates. There was some staining along the longer crack, indicating the crack was most likely a shrinkage crack from construction. Air voids are infilled with precipitates (ettringite and calcium hydroxide). A void, seen in Figure 5 (b), appears to be from an aggregate that popped out earlier or from a large entrapped air void

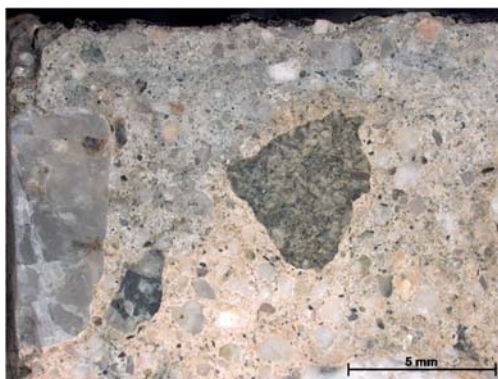
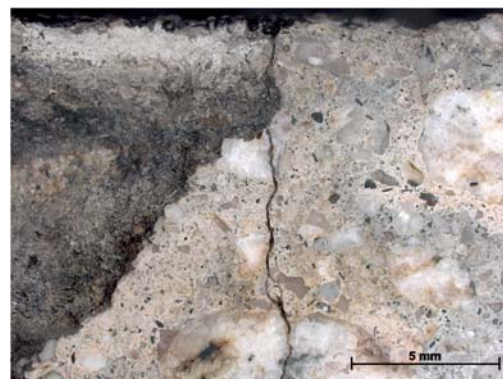
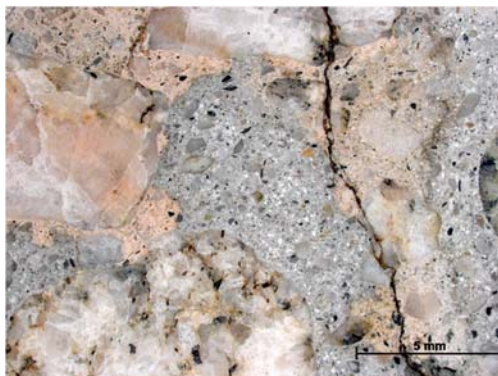
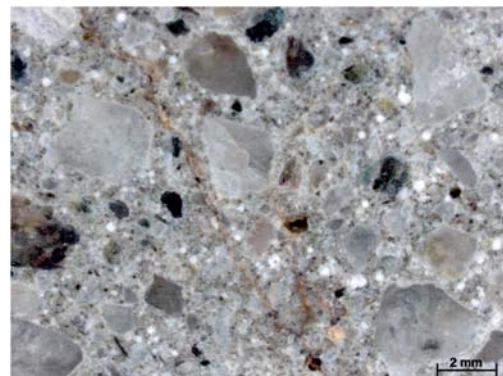
Figure 5. Low and High magnifications of 160143-2 (04T). (a) carbination sataining at the surface, (b) carbination stainging, crack at the surface, and large void most likely due to aggregate pop out, (c) carbination staining around cracked aggregate, (d) high magnification to see fine aggregate and cement, minir cracking.

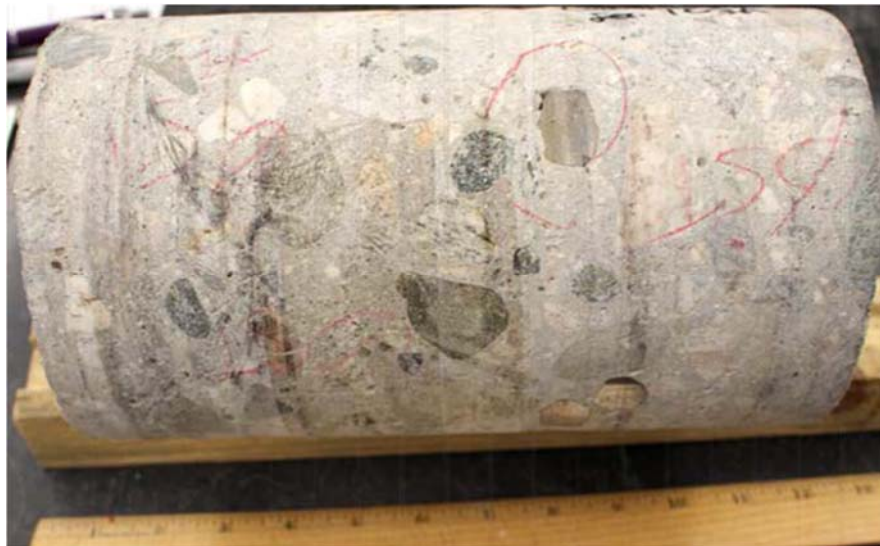
Figure 6. The as-received core 160143-3 (05T).

The as-received core 160143-3 (05T) is shown in Figure 6. The core was 9.75 inches long and 6 inches in diameter. There was minor carbonation staining within an inch of the surface. A crack was observed to extend 3mm, was less than 0.1 mm width and terminates at a coarse aggregate. Some crack was observed in the coarse aggregate of which followed the foliated fabric of the aggregate. Voids were partially infilled with a white deposit, most likely ettringite and calcium hydroxide. See Figure 7 for low and high magnification microscopy images of 160143-1 (02T).

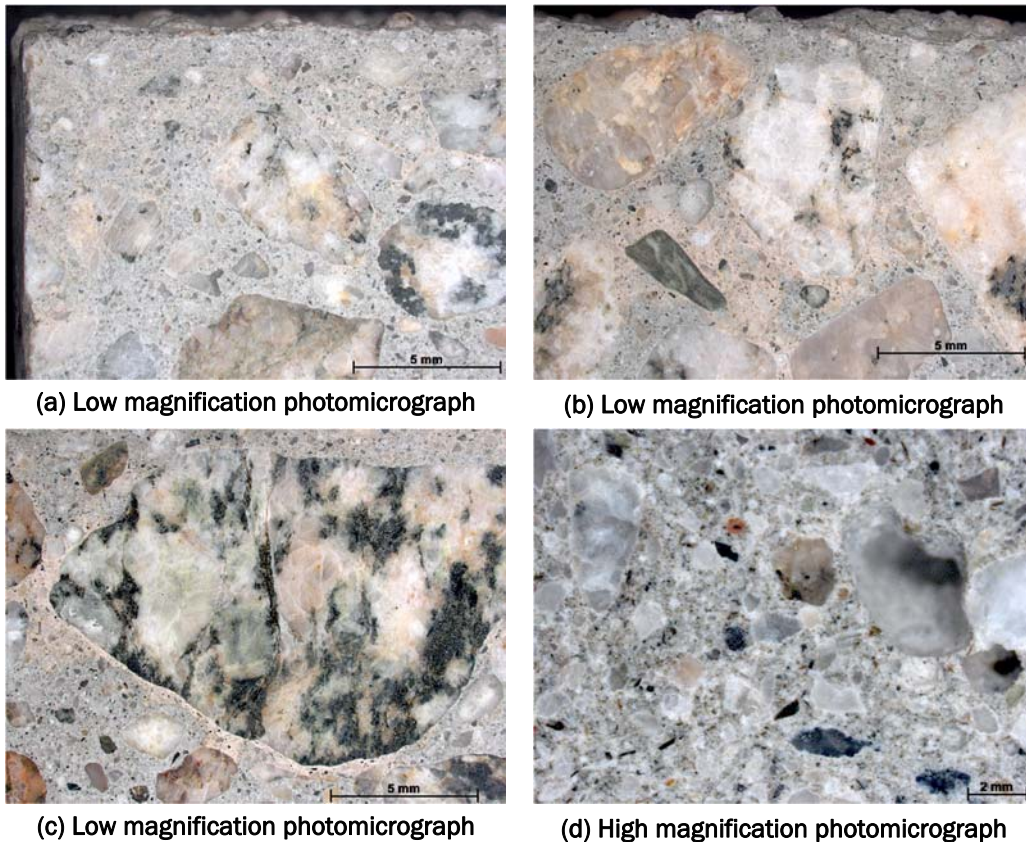
Figure 7. Low and High magnifications of 160143-3 (05T). (a) minor carbonation staining at the surface, (b) carbonation staining at the surface, (c) carbonation staining around cracked aggregate, (d) high magnification to see fine aggregate and cement.

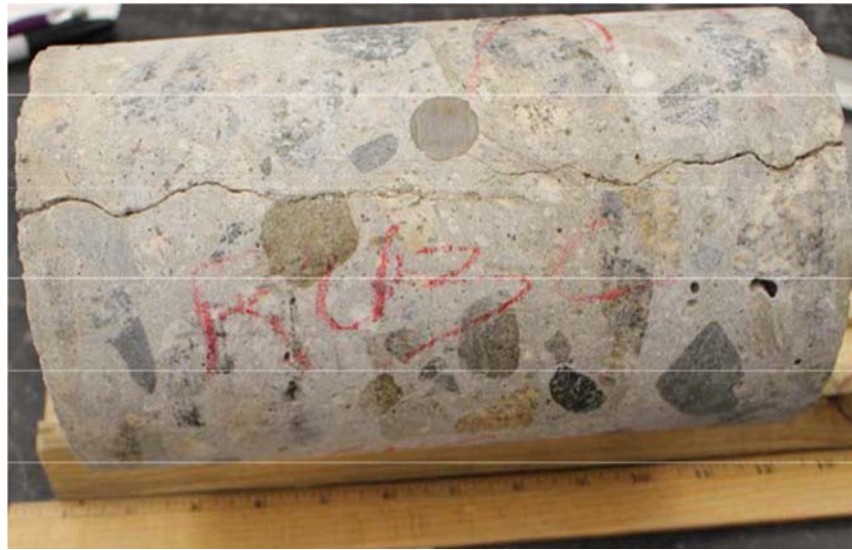
Figure 8. The as-received core 160143-4 (O8T).

The as-received core 160143-4 (08T) is shown in Figure 8. The core was 9.5 inches long and 6 inches in diameter. The large vertical crack in as-received core caused sample to separate upon cutting core. The crack did not appear to go through any coarse aggregates. Minor carbonation staining within an inch of the surface was observed. There was no visible signs of ASR gel or damage due to ASR gel expansion. Voids were partially infilled with a white deposit, most likely ettringite and calcium hydroxide. See Figure 9 for low and high magnification microscopy images of 160143-4 (08T).

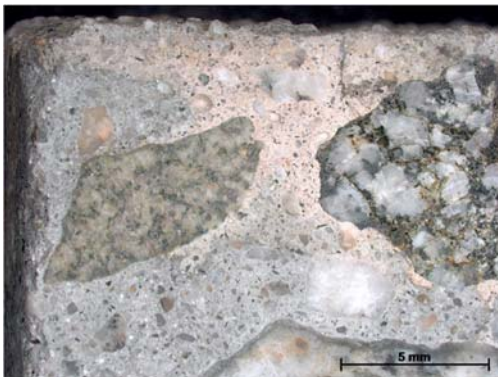
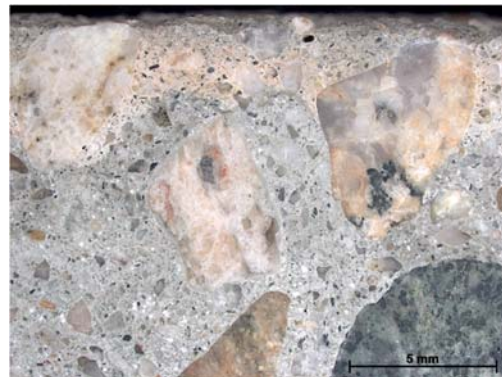
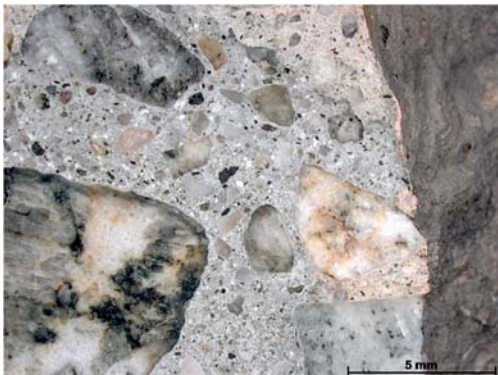
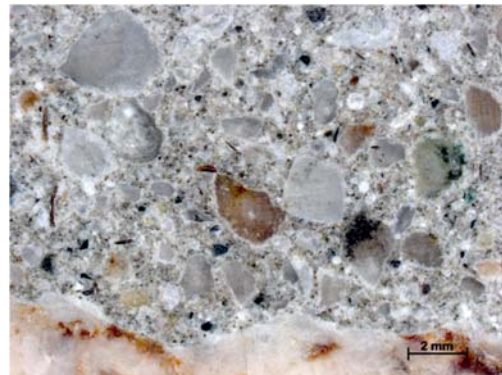
Figure 9. Low and High magnifications of 160143-4 (O8T). (a) minor carbination staining at the surface, (b) carbination staining at the surface, (c) carbination staining following preexisting crack, (d) high magnification to see fine aggregate and cement.

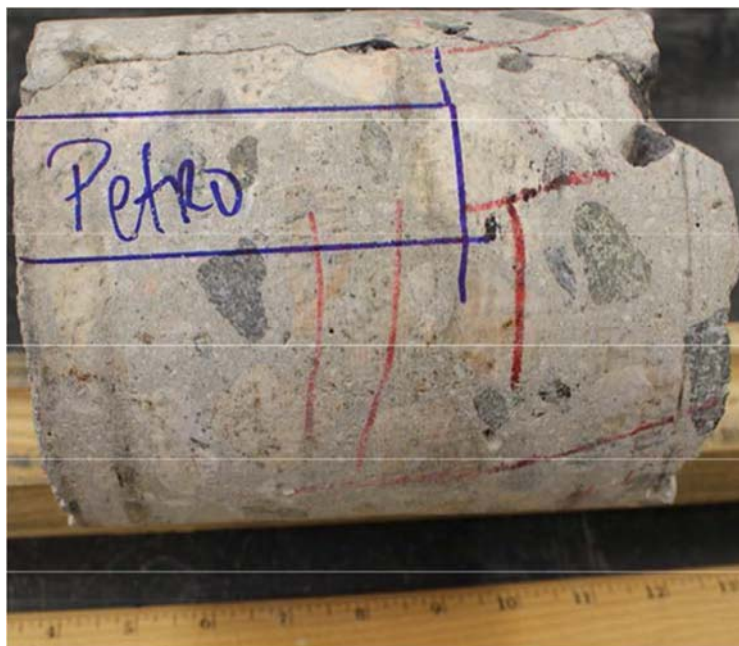
Figure 10. The as-received core 160143-5 (11T).

The as-received core 160143-5 (11T) is shown in Figure 10. The core was 6.5 inches long and 6 inches in diameter. Very minor staining at surface is due to carbonation and deeper in sample oxidation of iron oxide inclusions in aggregates. Voids were partially infilled with a white deposit, most likely ettringite and calcium hydroxide. There were 2 vertical cracks observed, the first extended 20mm, greater than 0.2 mm wide and terminates in a coarse aggregate. The second crack extended 12mm and terminated at a coarse aggregate, and was greater than 0.1mm width. This sample contained large entrapped air voids (greatest was 3/8" x 1/4"). A coarse aggregate has cracking throughout the aggregate, cracks follow the foliation of the aggregate and does not appear to extend into paste. Some of the microcracks appear to be infilled with gel, evidence of minor ASR. See Figure 11 for low and high magnification microscopy images of 160143-5 (11T).

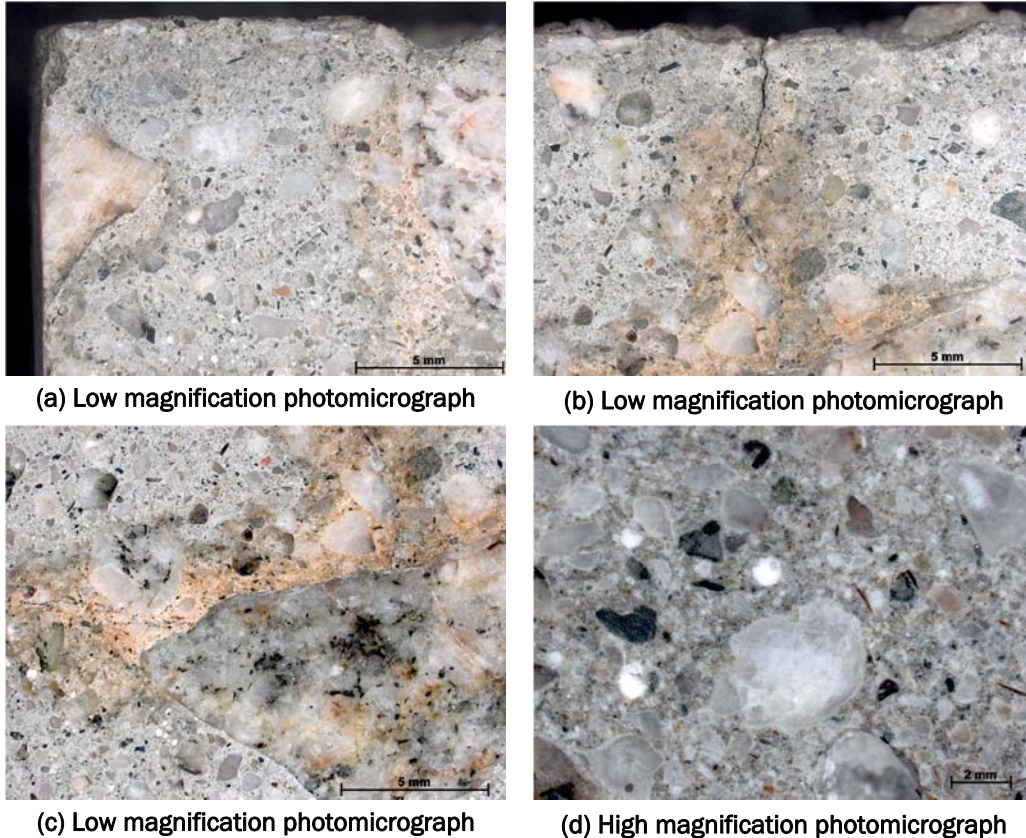
Figure 11. Low and High magnifications of 160143-5 (11T). (a) minor carbonation staining at the surface, (b) carbonation staining at the surface following older crack, (c) carbonation staining around coarse aggregate, (d) high magnification to see fine aggregate and cement.

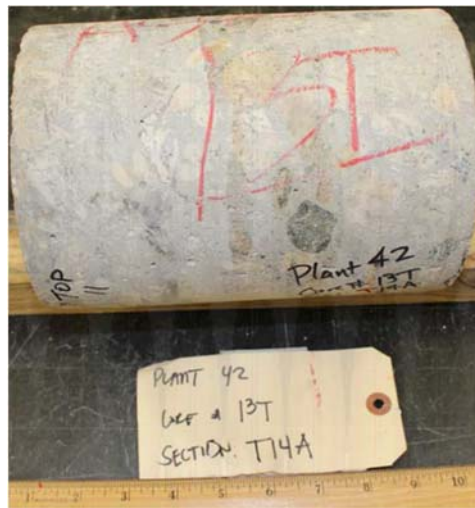
Figure 12. The as-received core 160143-6 (13T).

The as-received core 160143-6 (13T) is shown in Figure 12. The core was 6.75 inches long and 6 inches in diameter. Minor carbonation staining within a half inch of the surface was observed. There was no visible signs of ASR gel or damage due to ASR gel expansion. Voids were partially in-filled with a white deposit, most likely ettringite and calcium hydroxide. A crack, 11mm deep and less than 0.1mm width, was observed. Carbonation staining was observed along this crack. See Figure 13 for low and high magnification microscopy images of 160143-6 (13T).

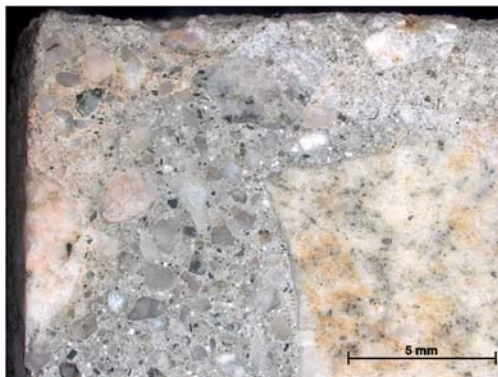
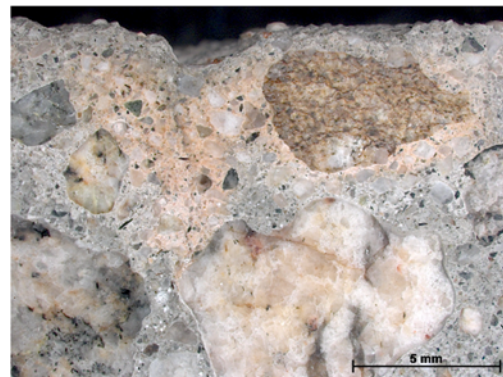
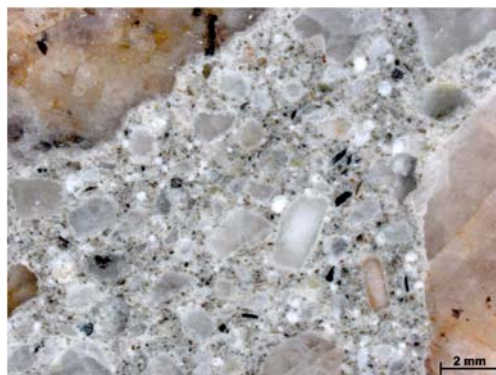
Figure 13. Low and High magnifications of 160143-6 (13T). (a) minor carbination staining at the surface, (b) carbination staining at the surface around coarse aggregates, (c) high magnification to see fine aggregate and cement.

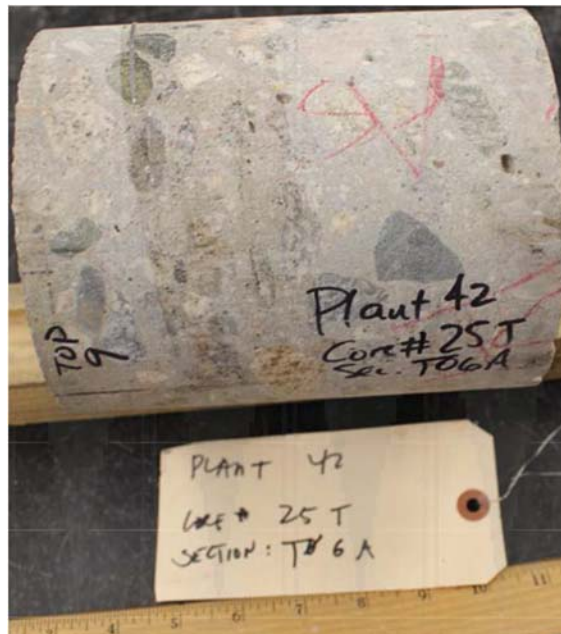
Figure 14. The as-received core 160143-7 (25T).

The as-received core 160143-7 (25T) is shown in Figure 14. The core was 7.5 inches long and 6 inches in diameter. Minor carbonation staining within an inch of the surface was observed. There was no visible signs of ASR gel or damage due to ASR gel expansion. Voids were partially infilled with a white deposit, most likely ettringite and calcium hydroxide. A crack extends 45mm from the surface and was greater than 0.5mm width. The crack extended around 1 coarse aggregate, but through 2 others, likely due to mechanical stresses. See Figure 15 for low and high magnification microscopy images of 160143-7 (25T).

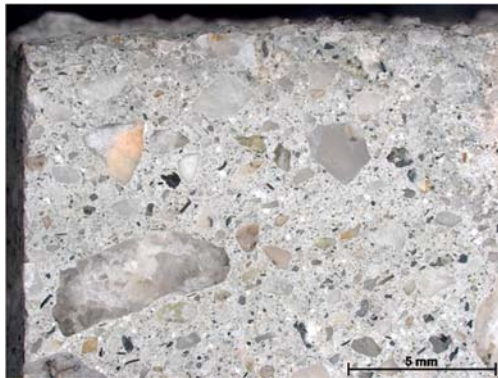
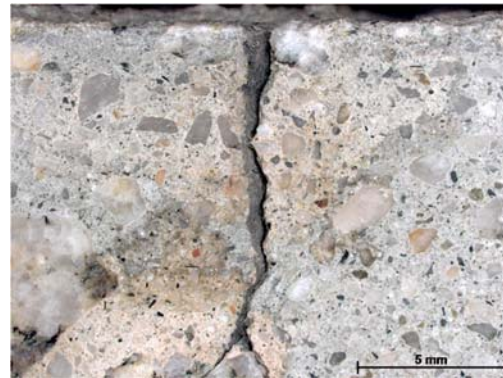
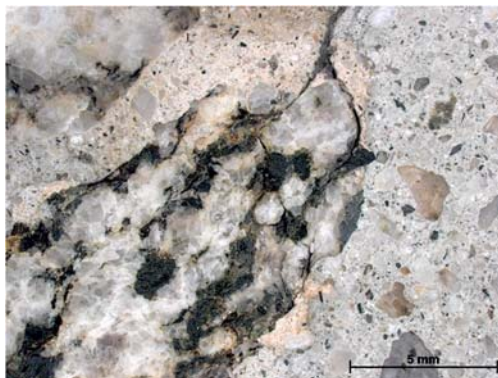
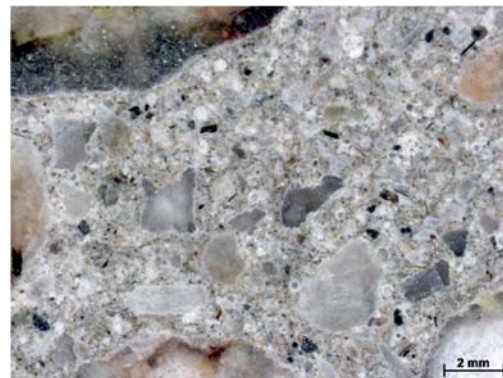
Figure 15. Low and High magnifications of 160143-7 (25T). (a) little to no carbination sataining at the surface, (b) carbination stainging at the surface following older crack, (c) carbination staining around cracked coarse aggregate, (d) high magnifiction to see fine aggregate and cement.

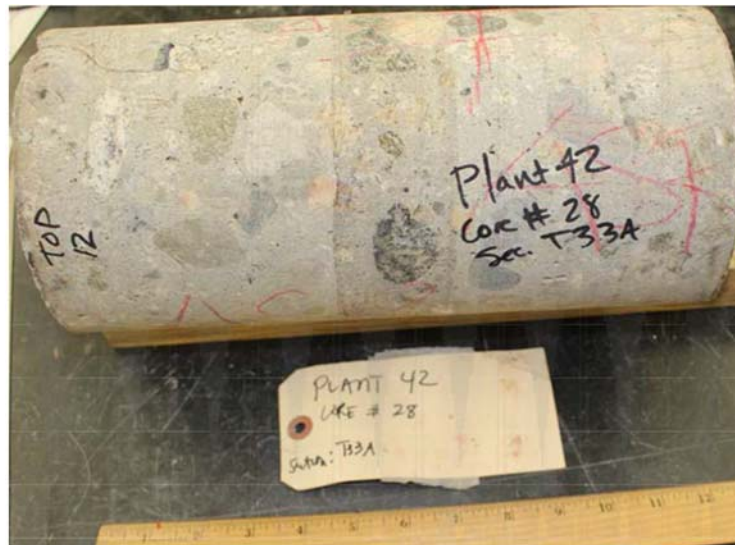
Figure 16. The as-received core 160143-8 (28).

The as-received core 160143-8 (28) is shown in Figure 16. The core was 9.875 inches long and 6 inches in diameter. Minor carbonation staining within an inch of the surface was observed. There was no visible signs of ASR gel or damage due to ASR gel expansion. Voids were partially infilled with a white deposit, most likely ettringite and calcium hydroxide. A crack extended through the sample, greater than 0.5mm width, but sample remained intact. The crack did not extend through any aggregates except the edge of one at 3 in in depth. See Figure 17 for low and high magnification microscopy images of 160143-8 (28).

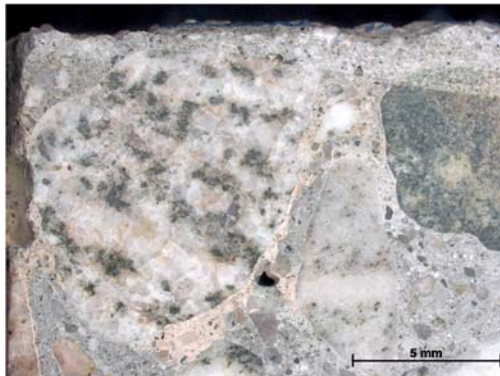
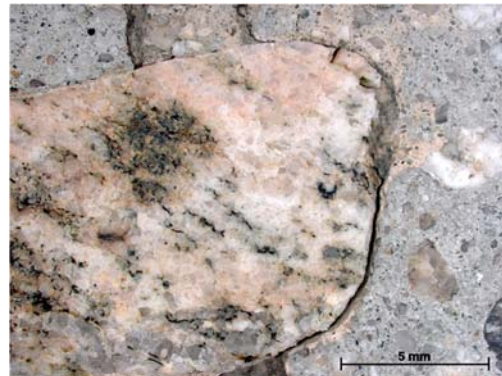
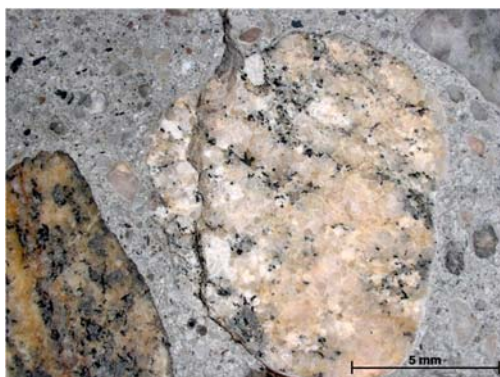
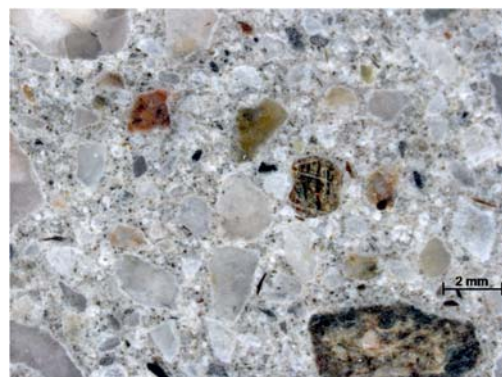
Figure 17. Low and High magnifications of 160143-8 (28). (a) minor carbination staining at the surface, (b) carbination staining following crack around coarse aggregate, (c) crack extending through coarse aggregate, (d) high magnification to see fine aggregate and cement.

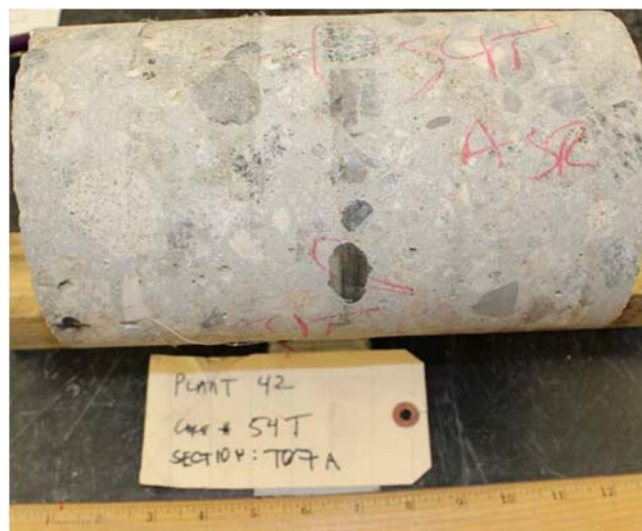
Figure 18. The as-received core 160143-9 (54T).

The as-received core 160143-9 (54T) is shown in Figure 18. The core was 6.75 inches long and 6 inches in diameter. Minor carbonation staining within an inch of the surface was observed. There was no visible signs of ASR gel or damage due to ASR gel expansion. Voids were partially infilled with a white deposit, most likely ettringite and calcium hydroxide. A crack at surface was 7mm deep and less than 0.1 mm in width, and terminates at a coarse aggregate. Coarse aggregate near the surface show signs of chemical weathering at grain boundaries within the aggregate, most likely due to wetting at the surface. Similar aggregates look like a gneiss and show no sign of weathering or chemical alteration with depth. See Figure 19 for low and high magnification microscopy images of 160143-9 (54T).

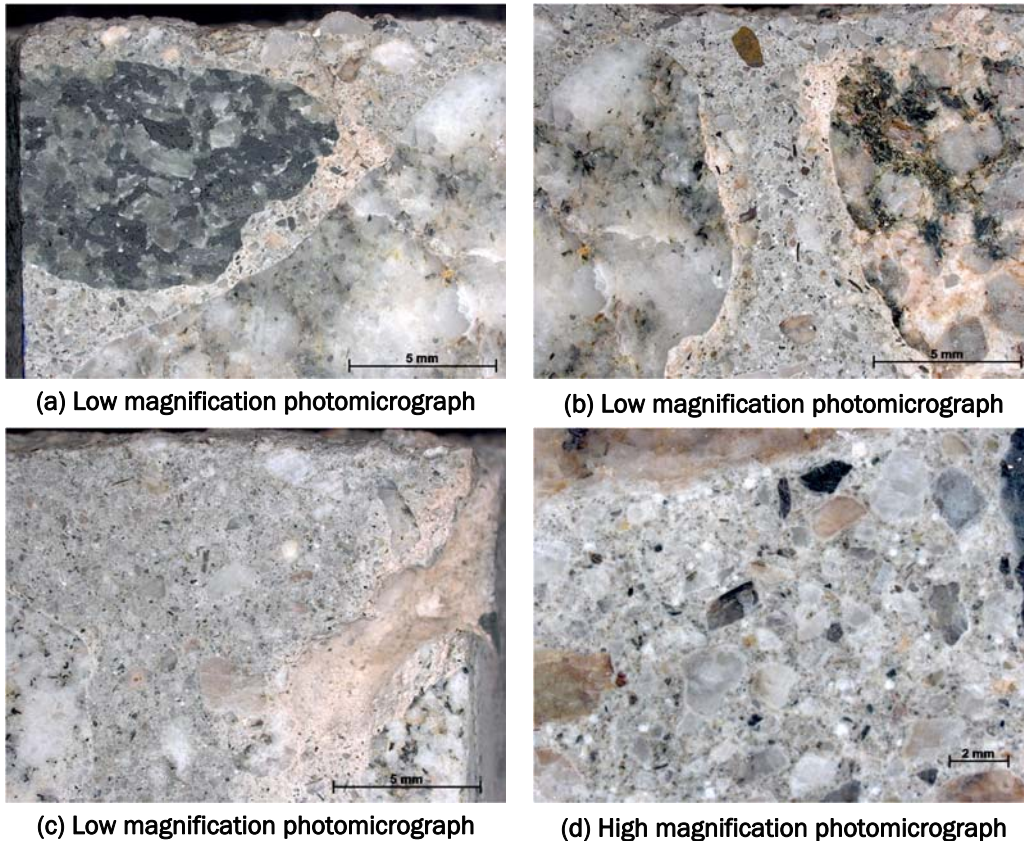
Figure 19. Low and High magnifications of 160143-9 (54T). (a) minor carbination sataining at the surface, (b) carbination stainging following coarse aggregate, (c) carbination staining in older void, (d) high magnifiction to see fine aggregate and cement.

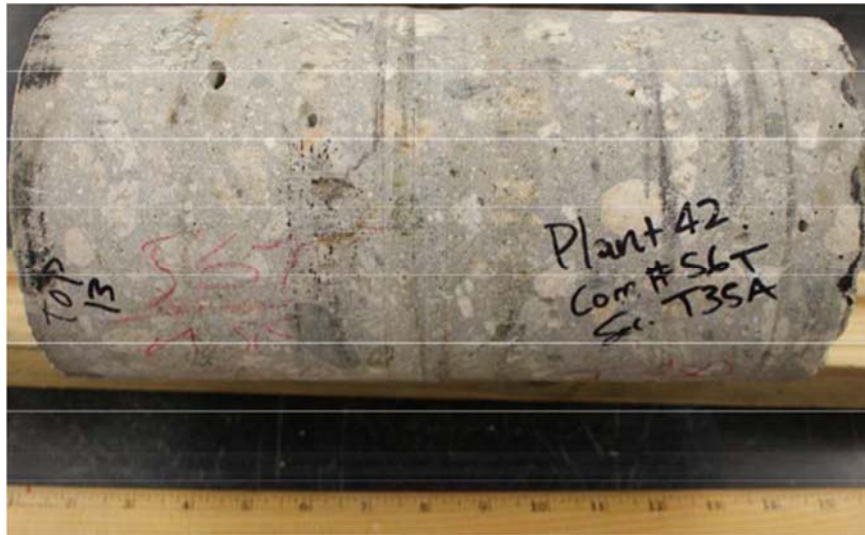
Figure 20. The as-received core 160143-10 (56T).

The as-received core 160143-10 (56T) is shown in Figure 20. The core was 9.5 inches long and 6 inches in diameter. There was no visible signs of ASR gel or damage due to ASR gel expansion, and no visible staining due to carbonation. Voids were partially infilled with a white deposit, most likely ettringite and calcium hydroxide. Two cracks were observed, both 20mm deep and greater than 0.2mm width. See Figure 21 for low and high magnification microscopy images of 160143-10 (56T).

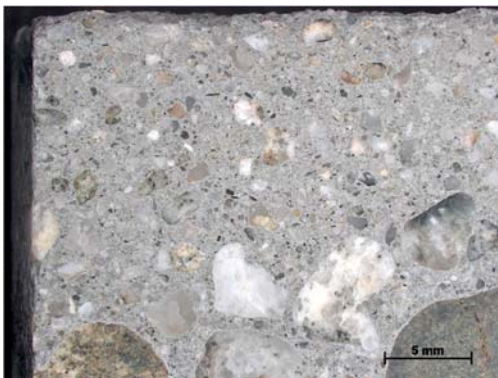
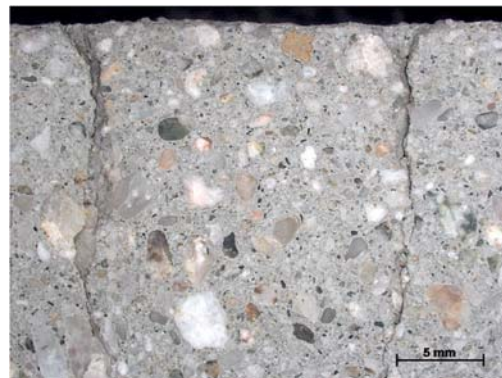
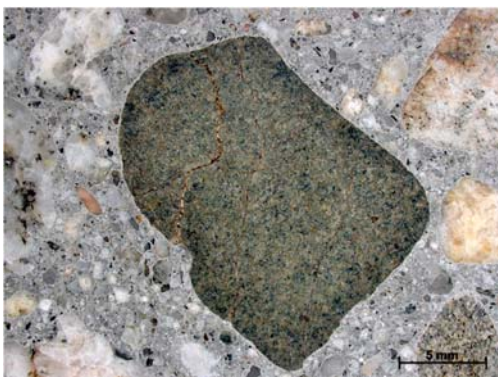
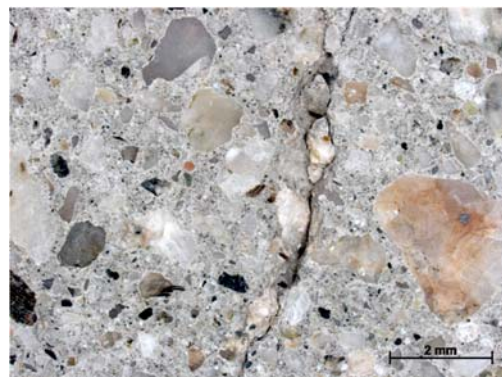
Figure 21. Low and High magnifications of 160143-10 (56T). (a) little to no carbonation staining at the surface, (b) cracks at the surface of the sample, (c) crack in coarse aggregate with iron staining, (d) high magnification to see fine aggregate and cement with cracking.

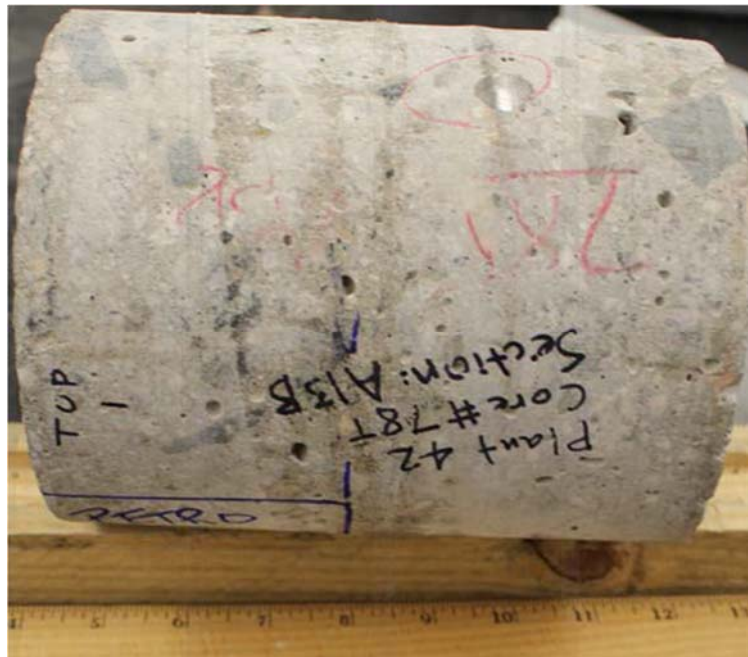
Figure 22. The as-received core 160143-11 (78T).

The as-received core 160143-11 (78T) is shown in Figure 22. The core was 6.75 inches long and 6 inches in diameter. Minor carbonation staining within an inch of the surface was observed. There was no visible signs of ASR gel or damage due to ASR gel expansion. Voids were partially infilled with a white deposit, most likely ettringite and calcium hydroxide. A crack was observed that extends 15mm from the surface and was less than 0.1mm in width. See Figure 23 for low and high magnification microscopy images of 160143-11 (78T).

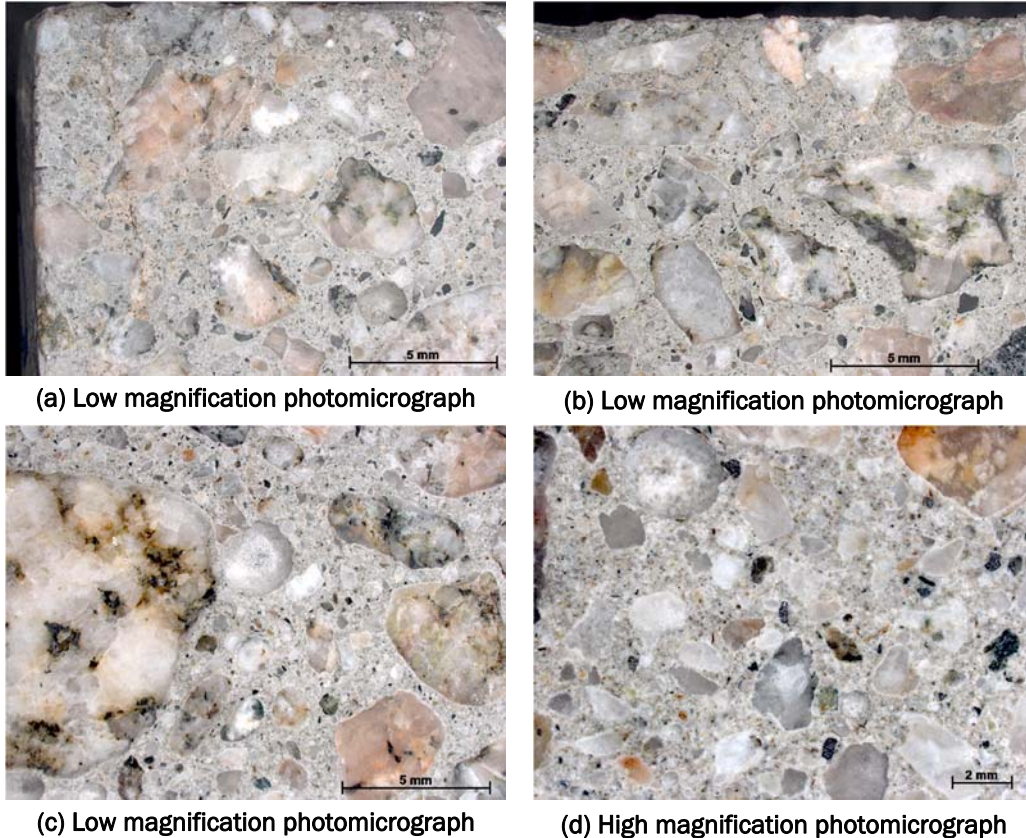
Figure 23. Low and High magnifications of 160143-10 (56T). (a) little to no carbonation staining at the surface, (b) little to no staining at the surface, (c) very little distress seen within the sample, (d) high magnification to see fine aggregate and cement.

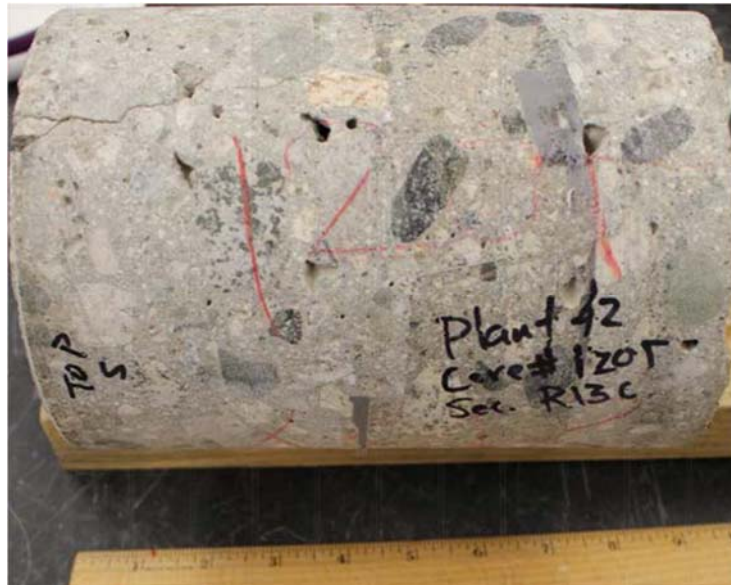
Figure 24. The as-received core 160143-12 (120T).

The as-received core 160143-12 (120T) is shown in Figure 24. The core was 7.75 inches long and 6 inches in diameter. There was no visible carbonation staining observed. There was no visible signs of ASR gel or damage due to ASR gel expansion. Voids were partially infilled with a white deposit, most likely ettringite and calcium hydroxide. A crack was observed at the surface, extends 30mm into sample and was less than 0.1mm in width. See Figure 25 for low and high magnification microscopy images of 160143-12 (120T).

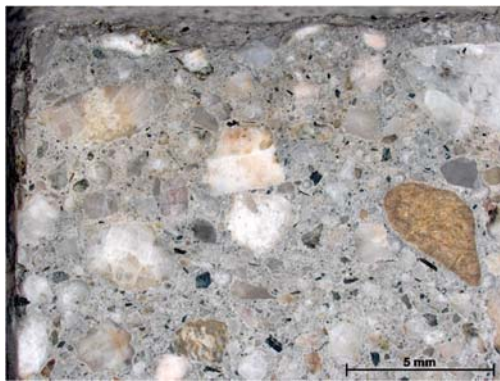
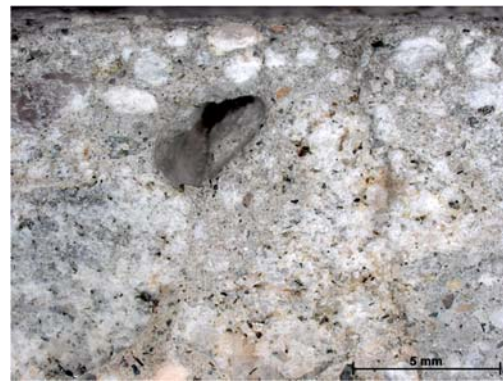
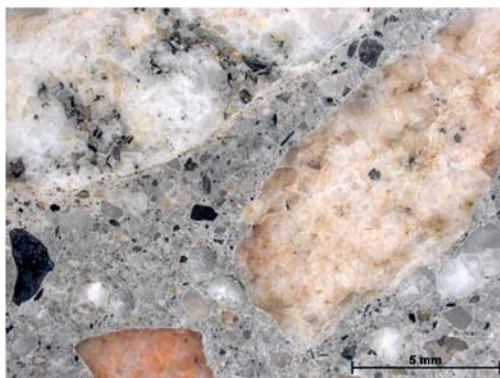
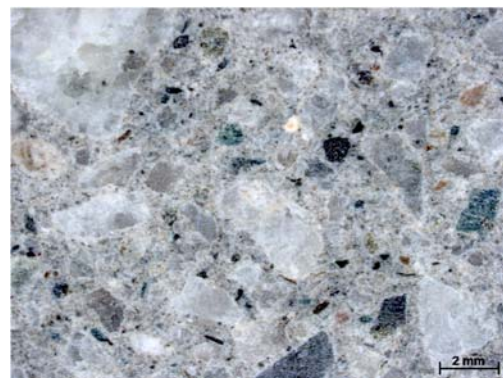
Figure 25. Low and High magnifications of 160143-12 (120T). (a) little to no carbination sataining at the surface, (b) fine crack at the surface of the sample, (c) minor staining around coarse aggregate, (d) high magnification to see fine aggregate and cement.

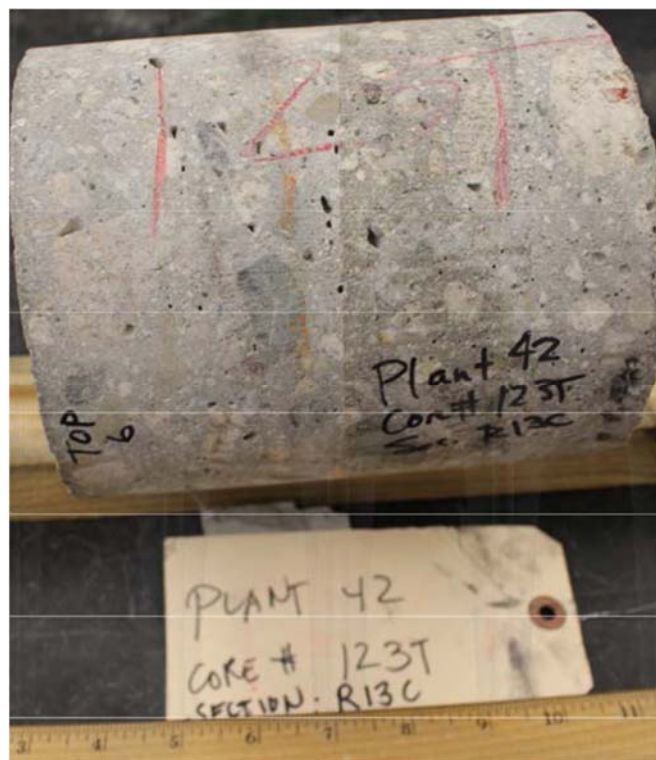
Figure 26. The as-received core 160143-13 (123T).

The as-received core 160143-13 (123T) is shown in Figure 26. The core was 6.625 inches long and 6 inches in diameter. Carbonation staining was observed only around large entrapped air voids. Large entrained air voids have little to no deposits of ettringite or calcium hydroxide. There was no visible signs of ASR gel or damage due to ASR gel expansion. Two cracks were observed in the core. The first; a 3 mm crack, less than 0.2mm in width extends from the surface, terminates at a large entrapped air void (1/4" x 3/4"), reappears at a coarse aggregate boundary and extends into another entrained air void (1/8" x 1/4"). The second was a 15mm crack that was less than 0.1mm in width. See Figure 27 for low and high magnification microscopy images of 160143-13 (123T).

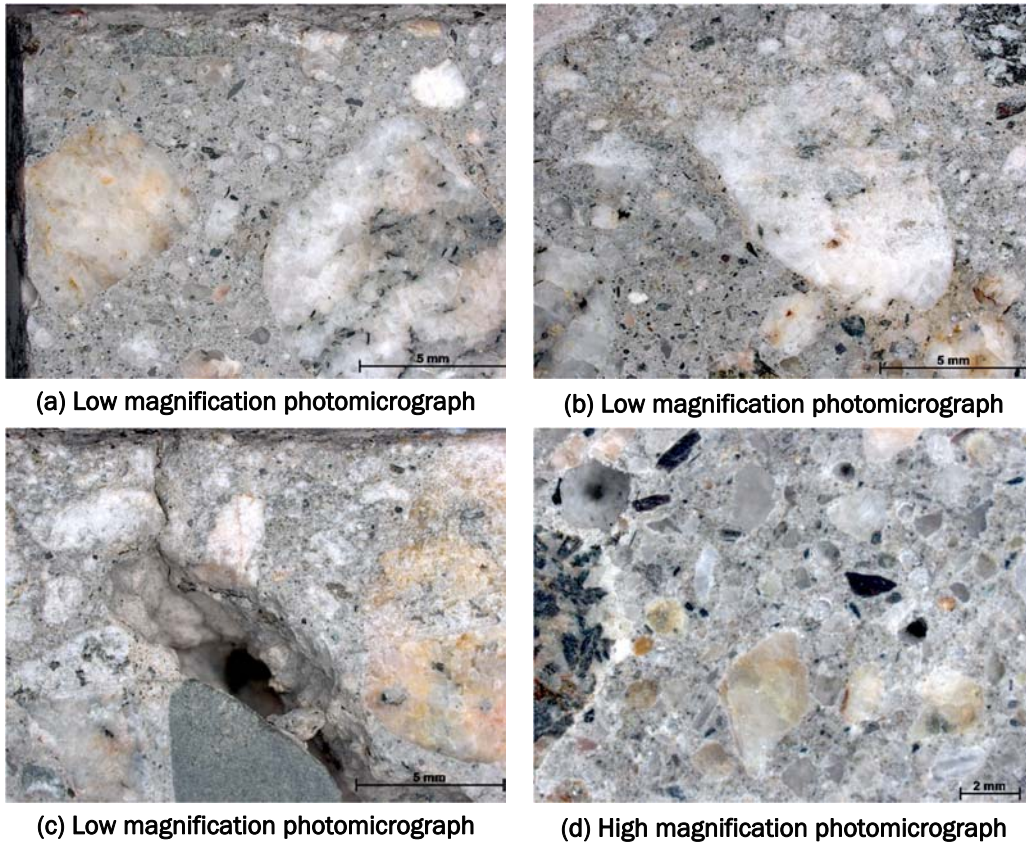
Figure 27. Low and High magnifications of 160143-13 (123T). (a) little to no carbination sataining at the surface, (b) minor staining around coarse aggregate, (c) cracking through large entrapped air void, with little to no staining, (d) high magnification to see fine aggregate and cement.

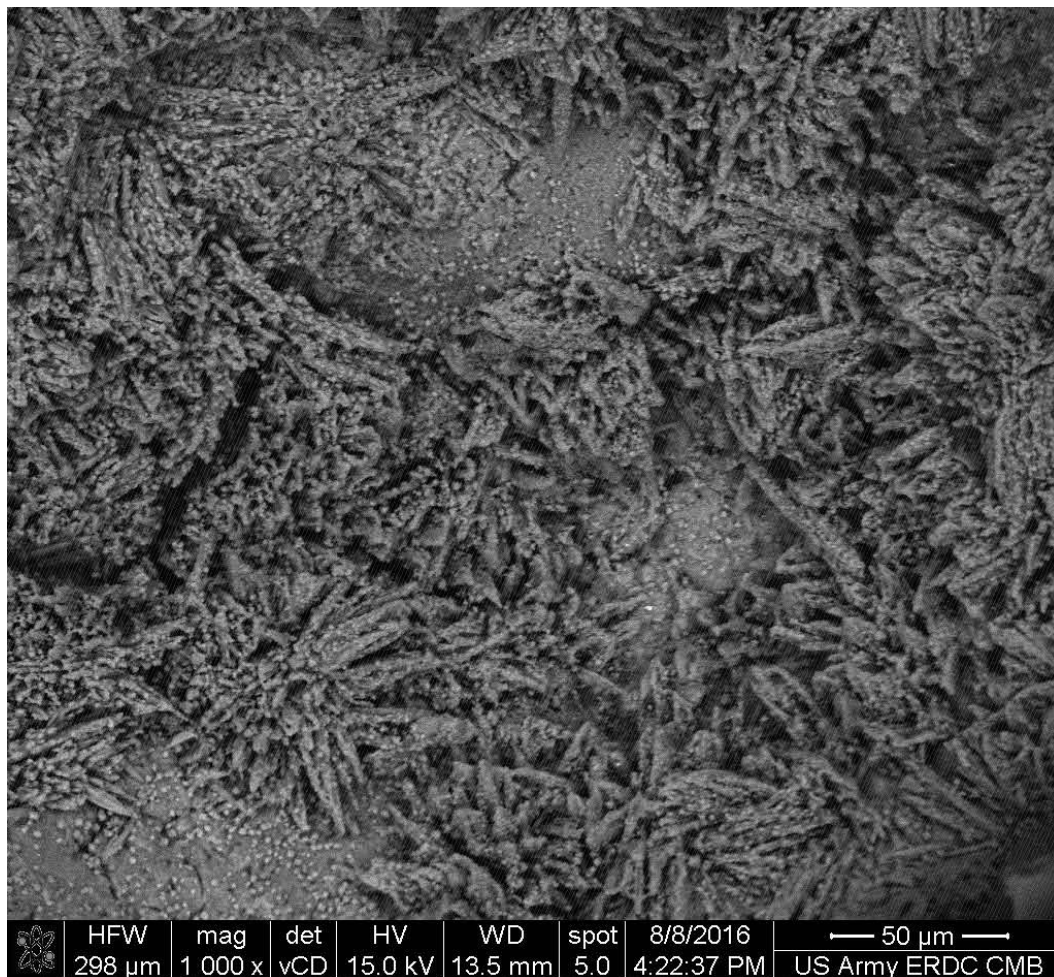
Core 160143-6 (13T) was evaluated in the SEM to determine the constituents of the white deposits that are found filling voids for most of the samples. In the image of a void, Figure 28, the radial needle-like crystals are ettringite and the smaller particles throughout the image are calcium hydroxide. If the deposits were ASR gel, there would be no crystal form and the gel would most likely be highly cracked.

Figure 28. SEM image of a void in core 160143-6 (13T). The radial needle-like crystals are ettringite, while the small particles are calcium hydroxide.
